A golden opportunity to transform eroded land

One of the Livestock café sites in the SLU-led Drylands Transform project was heavily eroded and parts of the land was impossible to use unless the gullies were rehabilitated. This gave the project a golden opportunity to conduct a training in land rehabilitation at the same time as trying to convert the land into something that can actually produce. To spread the knowledge of land rehabilitation, a training was conducted for using Vetiver grass in gully rehabilitation in Chepukat livestock café site in Chepareria ward, West Pokot County.

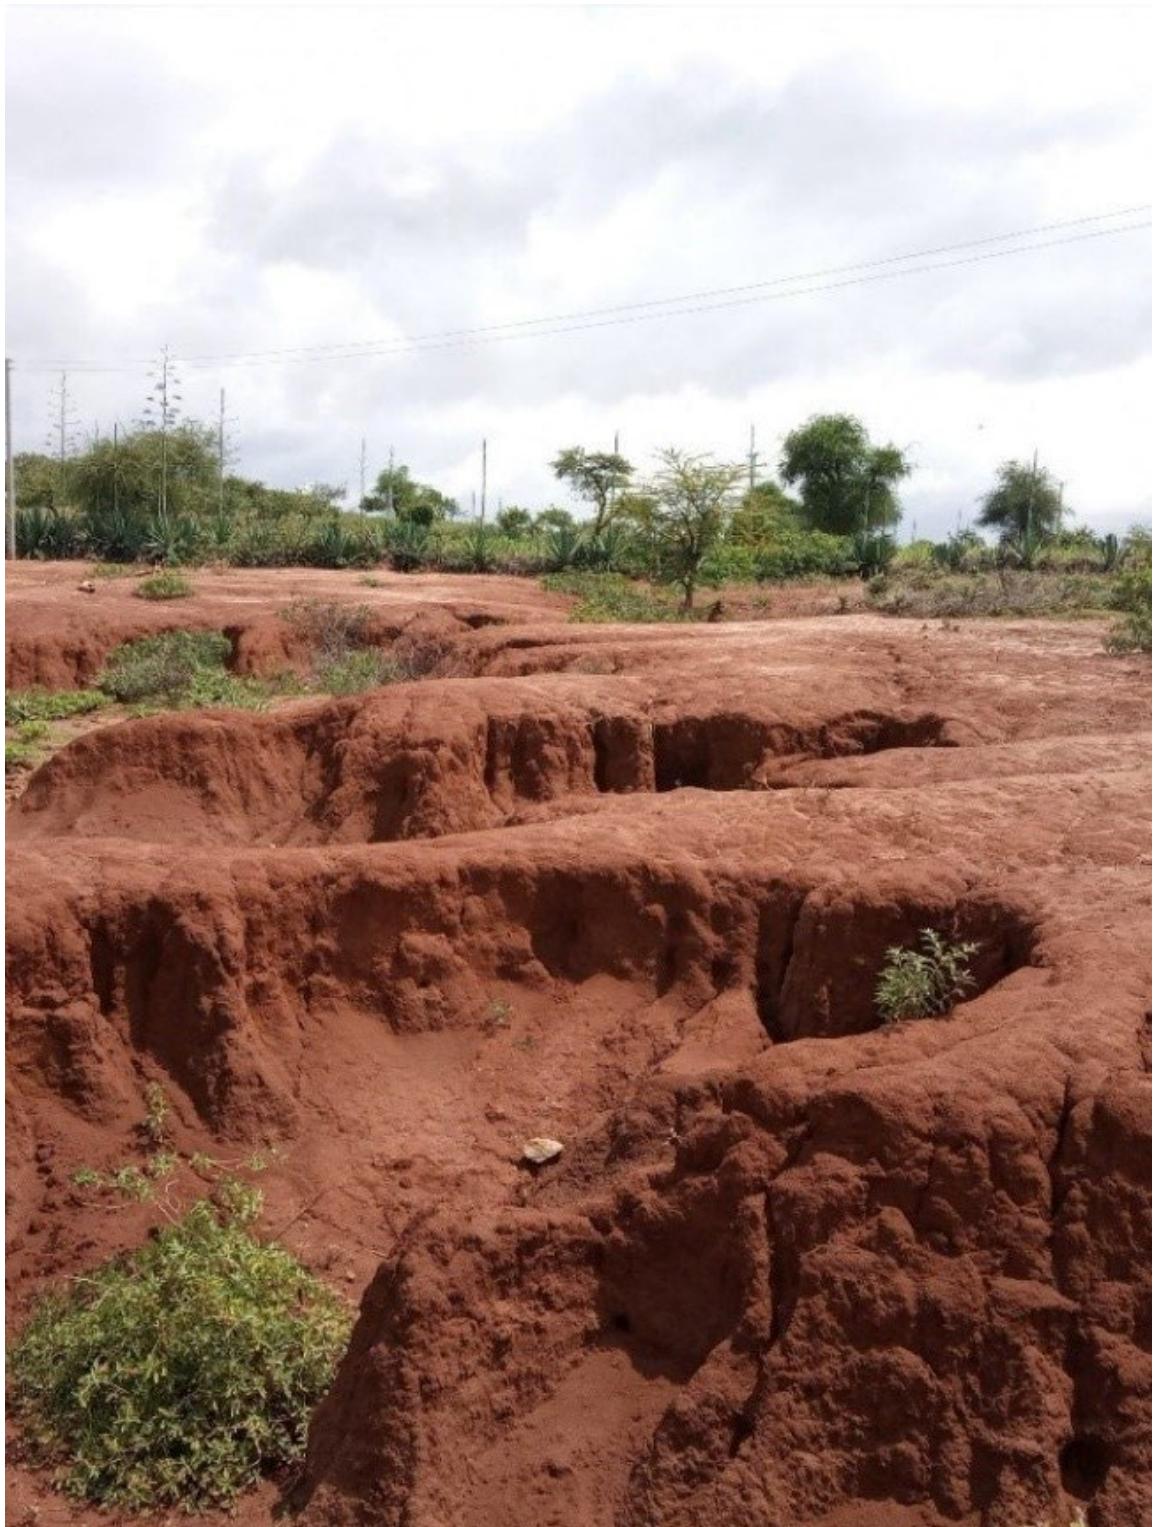
The landscape in West Pokot before rehabilitation. Photo: Margeret Nyaga

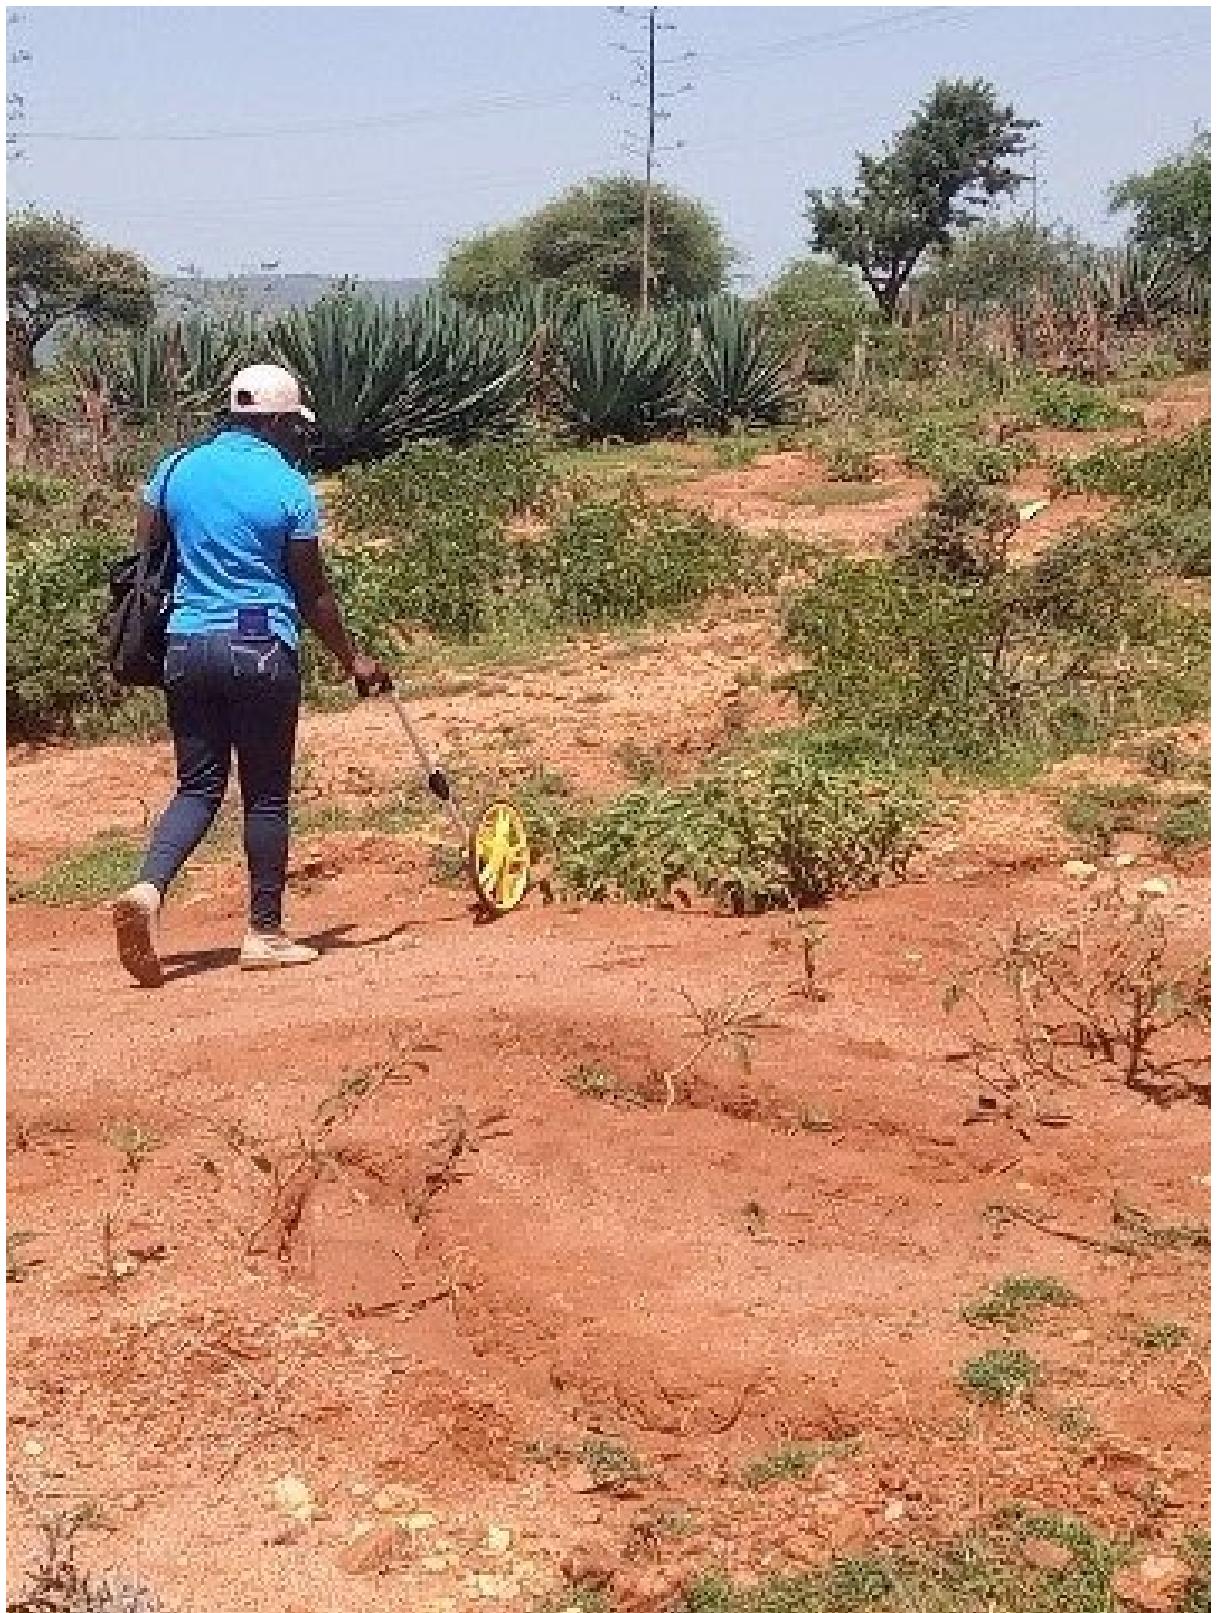
Margeret Nyaga is measuring the gully to be rehabilitated. Photo: Stephen Mureithi

The Vetiver trainer, Jane Wegesa together with her assistant Andrew Wekesa and Dr. Stephen Mureithi surveyed the site taking the measurements of the gullies. The length of the gully was 2456m and the width was 405m. Jane designed 7 contour lines along the main gully and more contours were concentrated at the gully head to reduce the pressure of surface run off down slope. The design also included reinforcement of the shoulders of the gully with bags and vetiver planted to prevent further erosion.

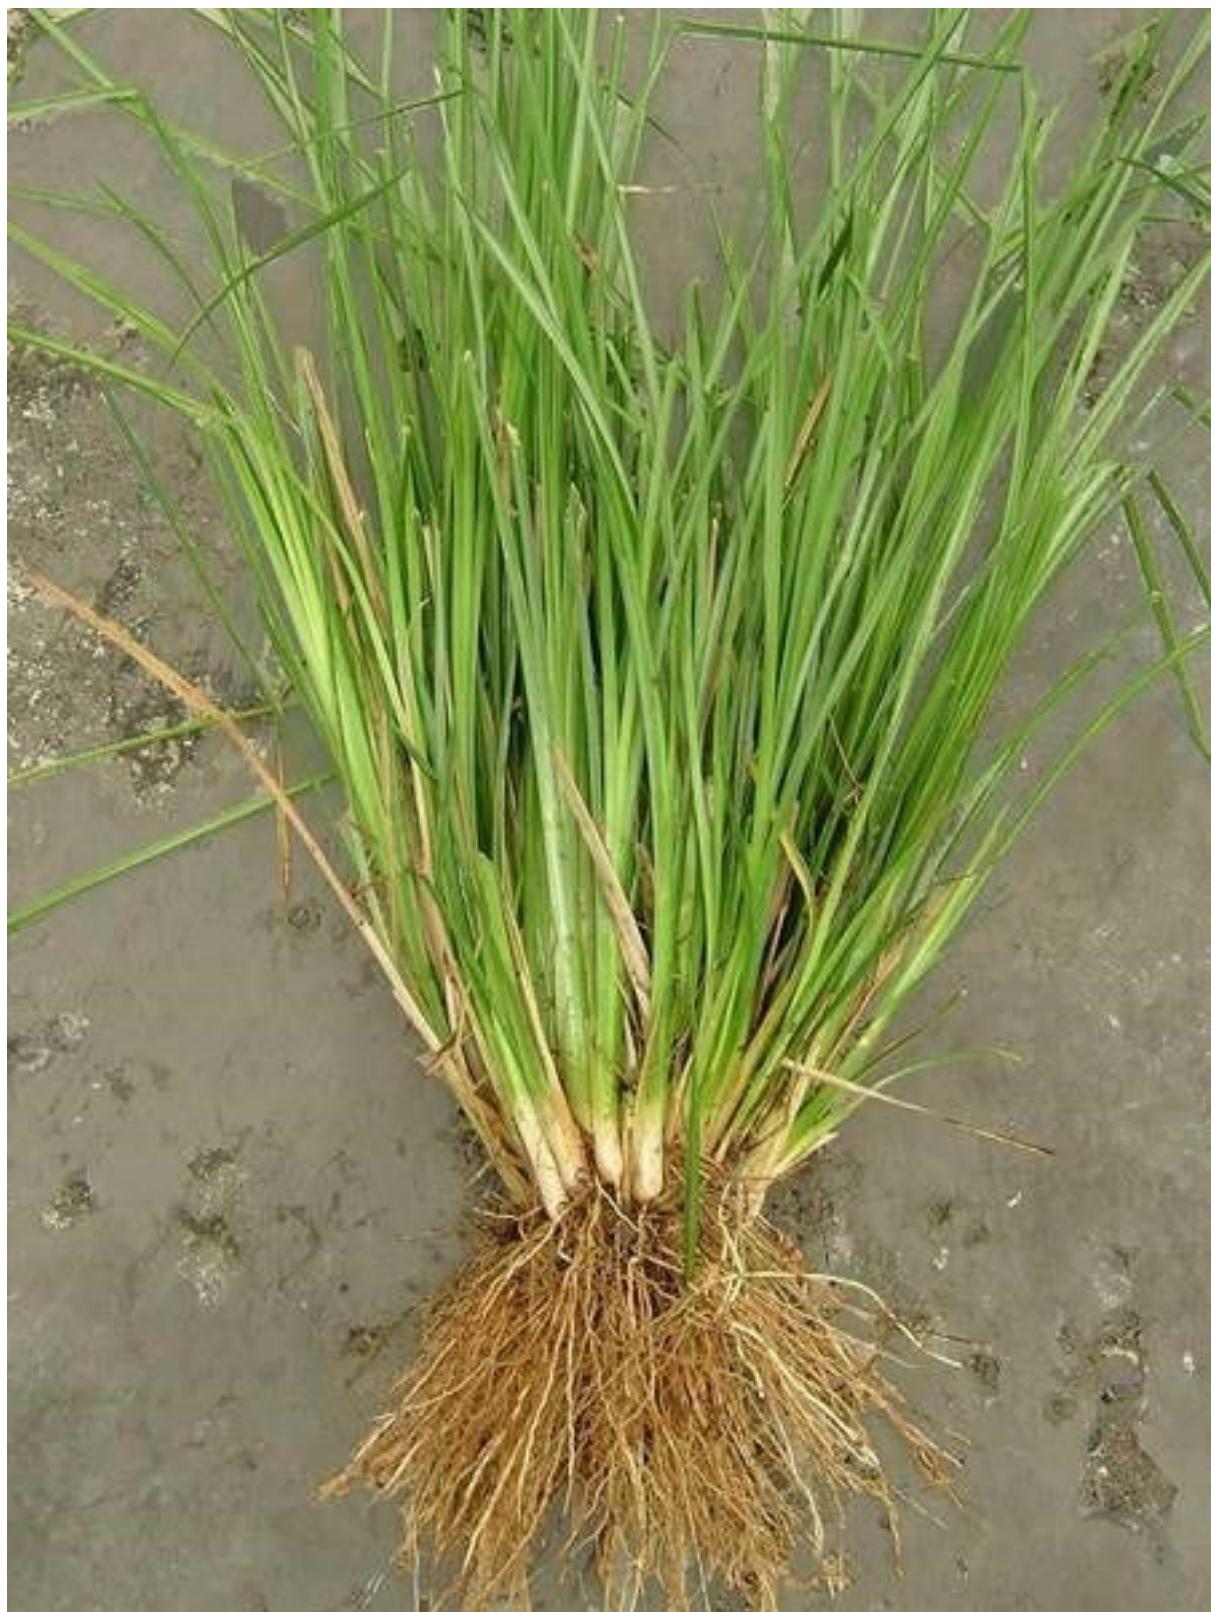
Vetiver grass can survive in places where it is hard for other grasses. Photo: Margret Nyaga

Vetiver grass can be easily established and can survive in conditions where other plants cannot. Drylands Transform aims to co-develop sustainable rangeland restoration and management options with the local communities and other stakeholders. The Vetiver grass technology was initiated as a tool to rehabilitate the severely eroded part of the Livestock Café site and showcasing it as one possible solution to other severely degraded hotspots in West Pokot County.

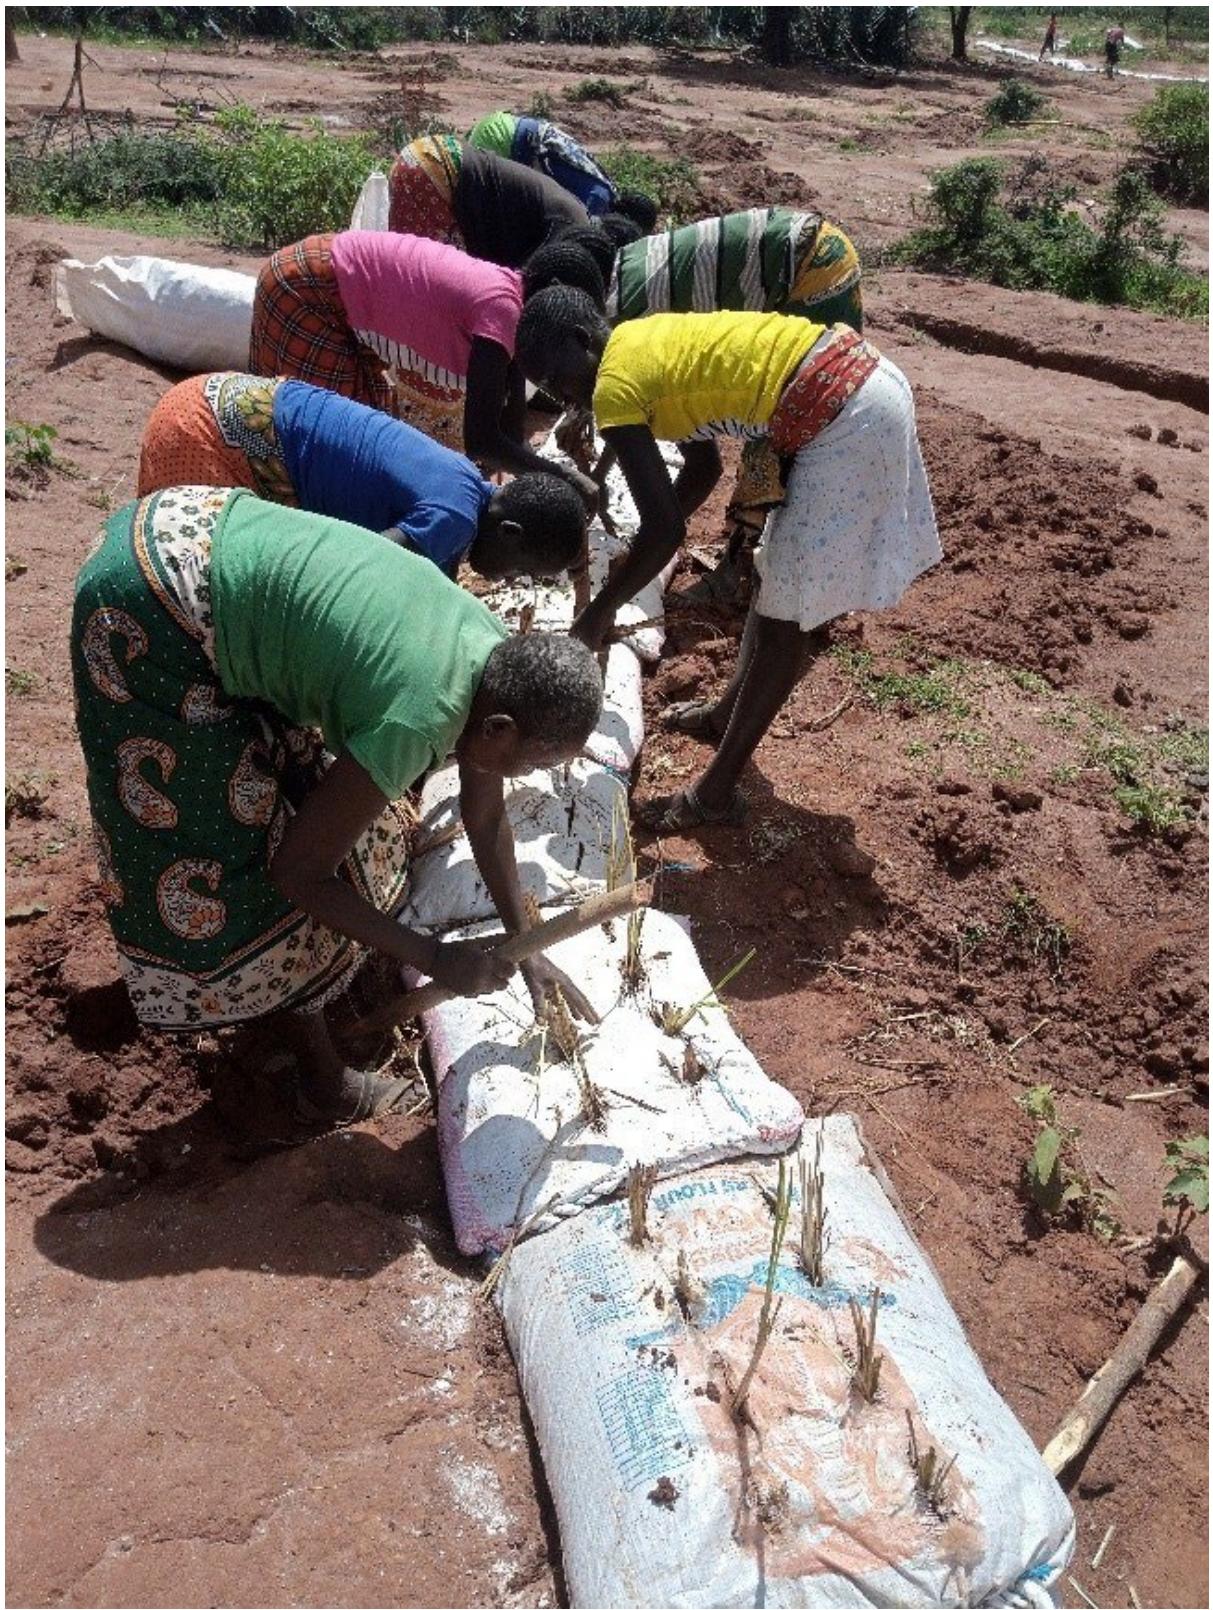
Women plant Vetiver grass splits into the sacks. Photo: Margeret Nyaga

Most part of the training was spent on mixing the material for the sacks and placing them along the contours. The ratio of sand, soil and manure used was 2:3:1. The mixtures were put in sacks weighing 50kgs and placed horizontally along the previously marked contour lines after leveling the ground. The sacks help in reducing the evaporation of water allowing the vetiver splits to establish. This is important especially in the arid and semi-arid areas where the evaporation rates on bare soil is high.

Finally, after the soil bags were properly laid onto the marked contour lines and firmly pinned with some wooden pegs, small openings were made using a knife to open up spaces for planting the Vetiver grass splits. The community members were divided into groups to plant the grass after demonstrations

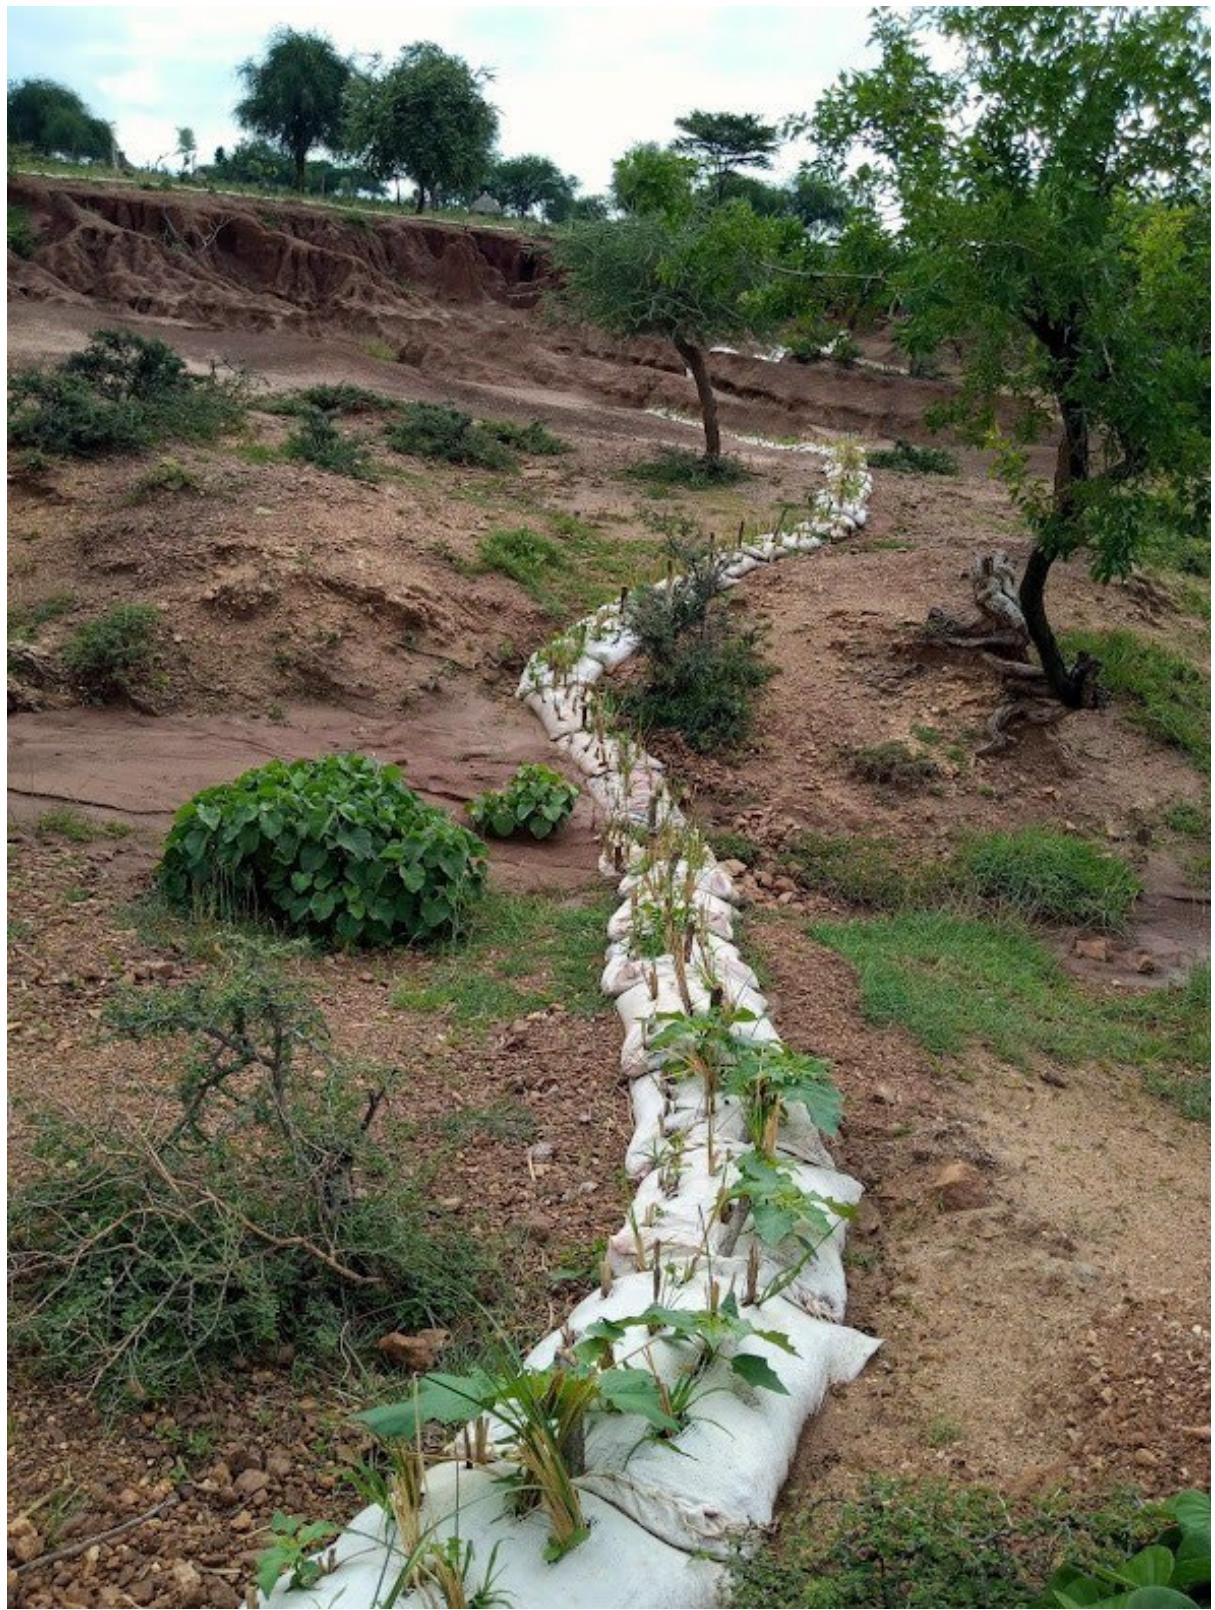
After rains, the vetiver grass has started growing well in the sacks while it is empty beside. Photo: Margeret Nyaga

The establishment of the Vetiver grasses on contours was successful due to timely rains and the next steps will be to initiate more restoration practices along the contour lines and other parts of the site, such as planting of trees and other grass species to bolster success.
